APPENDIX 8.1
Walkover Survey Photographs

Walkover Survey

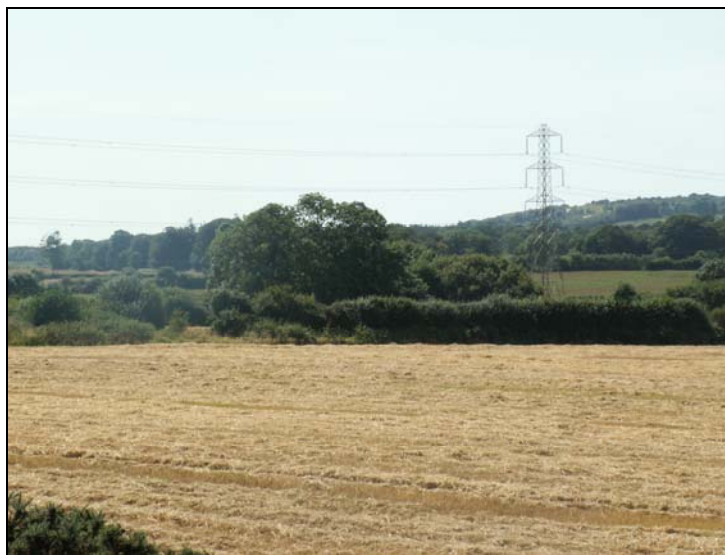
Plate 1: The southern portion of the development area. View to the northwest.

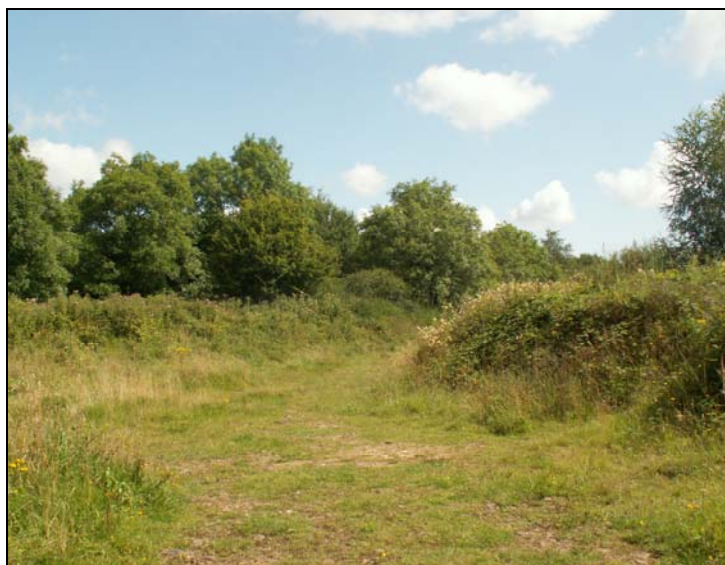
Plate 2: Site of the Island Farm prisoner of war camp (ID 02214m/31802). View to the east.

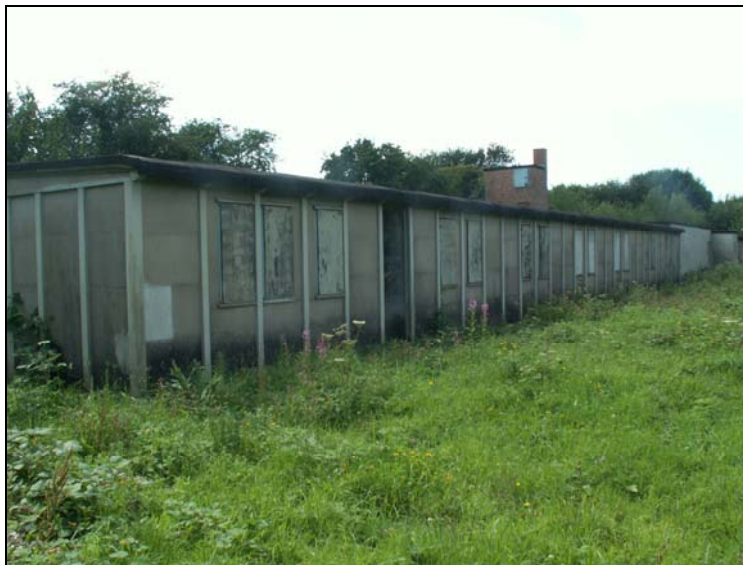
Plate 3: Northern accommodation wing, Hut 9 (ID 02215m/31803/LB11362).

View to the southwest.

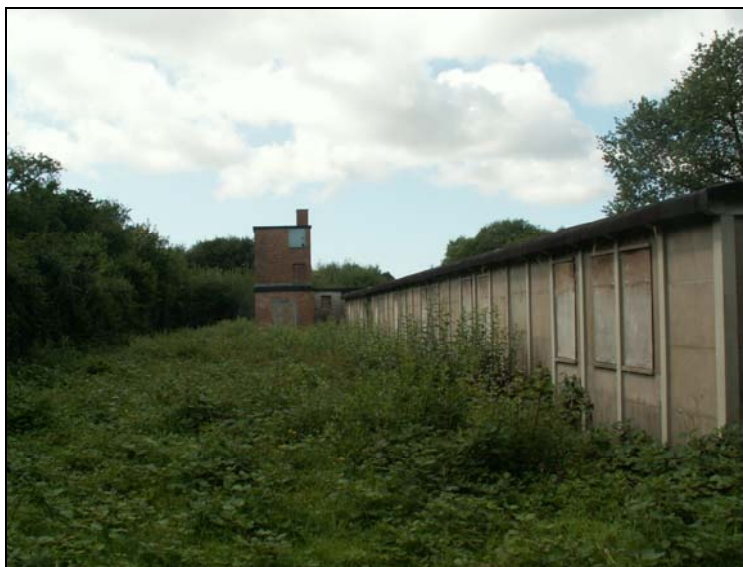
Plate 4: Central boiler room and water tank, Hunt 9 (ID 02215m/31803/LB11362). View to the northeast.

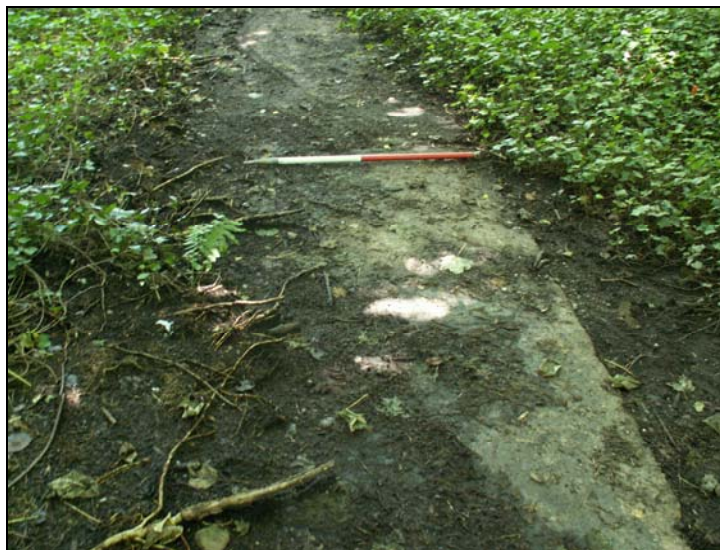
Plate 5: Concrete path forming part of Island Farm prisoner of war camp (ID 02214m/31802).

View to the northwest.

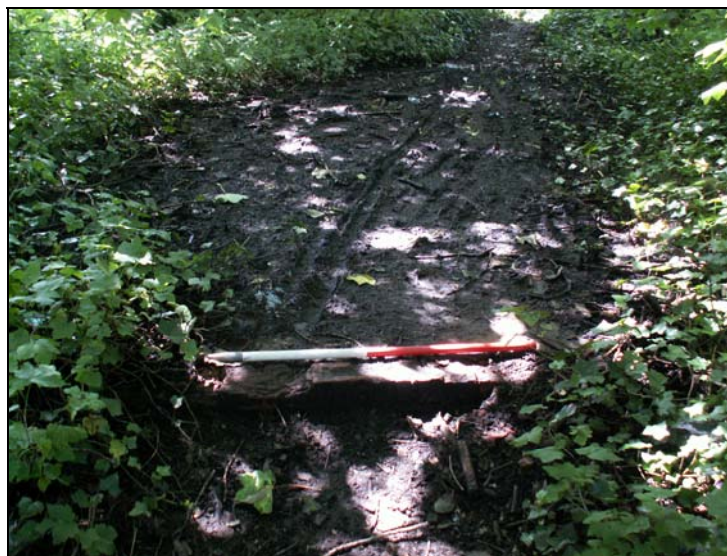
Plate 6: Brick-built base to prisoner hunt, forming part of Island Farm prisoner of war camp (ID 02214m/31802). View to the east.

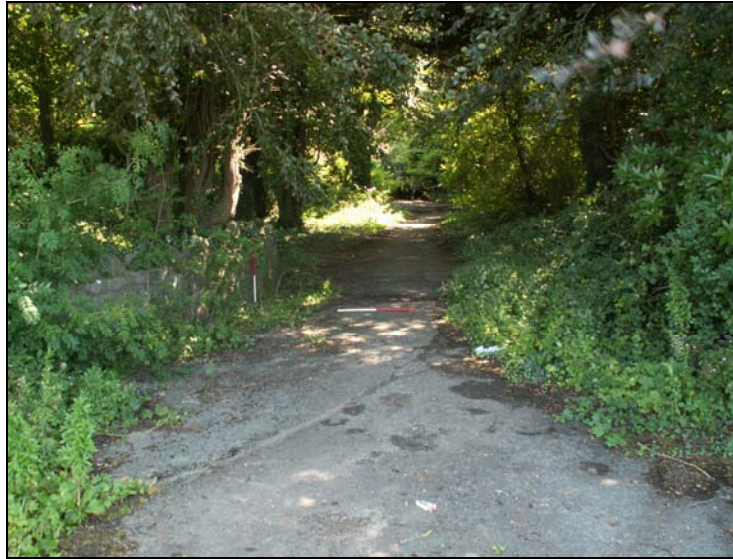
Plate 7: Tarmac driveway leading to Crossways (ID IF09). View to the east.

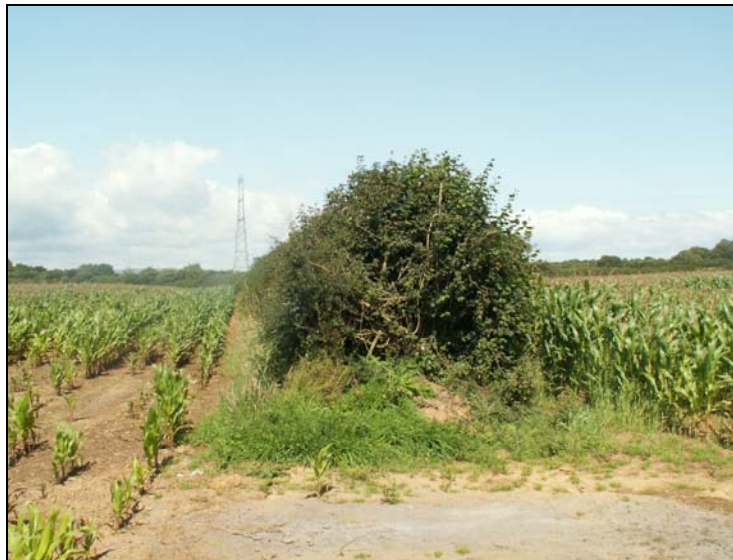
Plate 8: Hedge marking the route of Trackway (ID 04354.0m). View to the north.
